Cabling and Platform Solution
Project 200-215
Final Report
Reporting Period 15 Feb 2022 – 31 Mar 2022

Halagonia Tidal Energy Limited

Project Lead: Sarah Thomas
Project Start Date: 11 Feb 2020

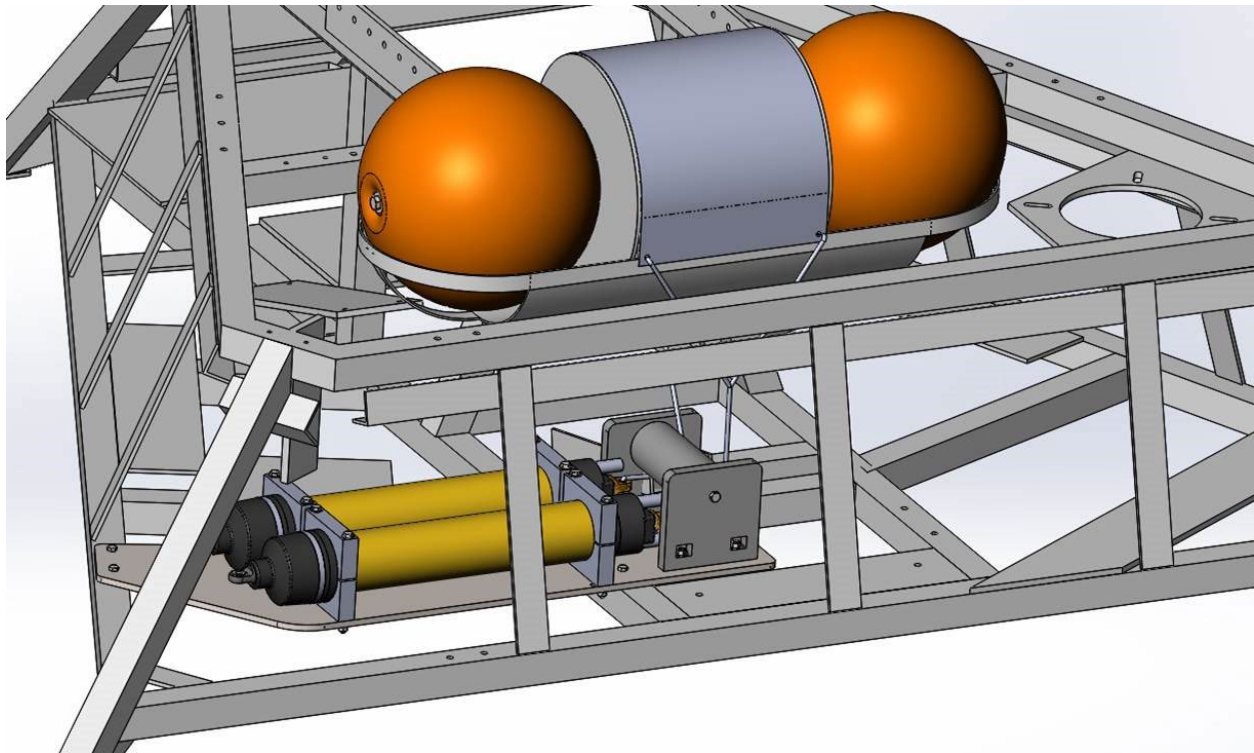
Figure 4: Acoustic Release system

As discussed in the Lessons Learned section, this system failed twice, with the floats surfacing prior to the acoustic release being tripped. This system requires robust redesign for long term (> 8 week) deployments. The initial failure was investigated upon the first recovery. That report has been provided in Appendix 1 for review. It appears the rope holding the canvas spool cover chafed to the point of

failure where it meets the grommet. This rope was replaced with dyneema for the second operation. Upon recovery, the failure mode will be further investigated.

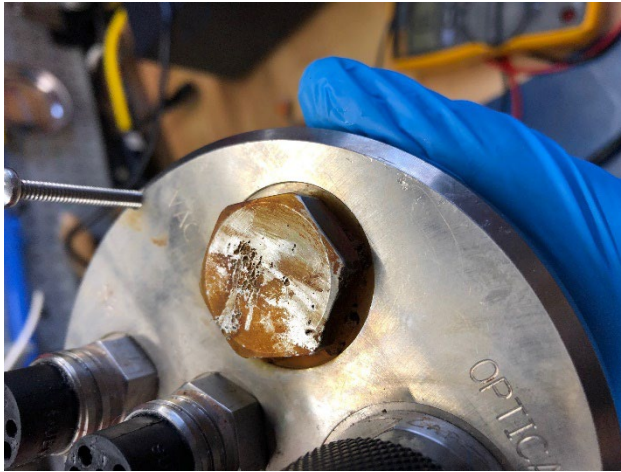
The VAC plug (circled in Figure 14 above) is the component that showed evidence of corrosion upon recovery in September 2021. This plug is galvanically isolated from the frame through the acetal mounting bracket, so it was not protected by the sacrificial anodes installed on the frame. MacArtney Canada completed a metallurgical analysis and confirmed the component was 316 stainless steel. However, after reviewing documentation from their supplier, it was confirmed that the plug was not passivated and therefore was not protected in the saltwater environment. The component was replaced with a titanium piece in the refurbished MUX.

Figure 15: Corroded MUX Plug

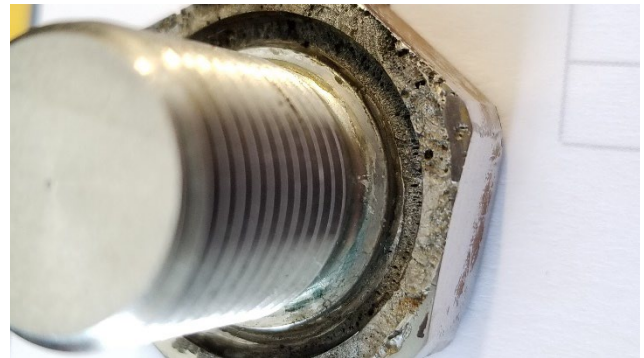
Figure 16: Corroded MUX plug, threads

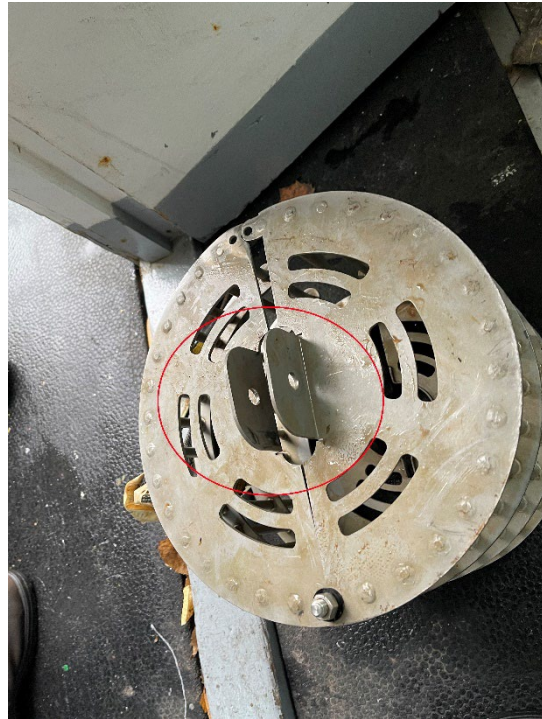
Figure 31: Cable Connector Protection Cage

Cable Connector Protection Cage Design and Fit Issue: The cage was originally designed did not allow access to the shackle, which is essential in securing the cable/Trustlink on deck. This caused problems in the future retrieval of the cable, more particularly in the way we had to tie the cable off and secure it. With the cage not fitting properly, the cable was hard to manage and created a less than favourable bend near the bend restrictors. The ears on either side of the cage prevented the cages from fitting and closing properly over the truss link. The cage was modified at the next opportunity. The ears identified in the circled area in Figure 31 were removed and that allowed for the cage to fit better over the Trustlink and allow the cage to close properly without having to use zip ties. This also allowed for the shackle to be connected to the Trustlink to allow proper attachment of a ground line. An issue with the hinge also presented itself after the second retrieval of the cable and cage. Modifications were made to the cage for the redeployment that should resolve the issue.

Solution: Recommend manufacturing another cage taking into consideration the modifications that were made to this one. Also, a single long pin or bolt on the hinged side of the cage with safety pins in place to avoid nuts backing off and cage coming off.

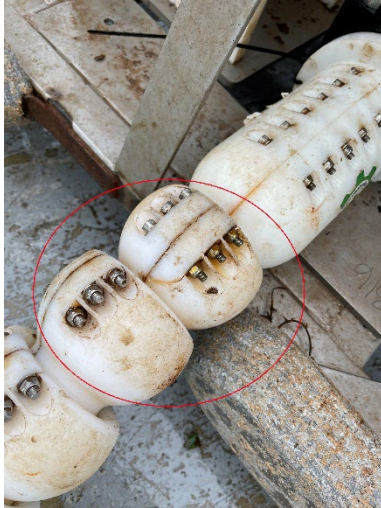
Figure 33: Crack in Bend Restrictor

There was also a small crack in the material on the first clam shell set after the transition piece (see Figure 33).

Solution: Recommend extending a metal bar out under the transition piece and past the second or even third set of clam shells on the bend restrictor assembly. This would provide support to the assembly and help prevent the possibility of the cable folding back under the platform on set down.

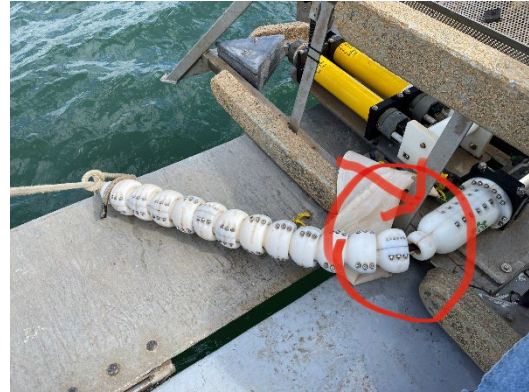
Figure 32: Bend Restrictor Separation

Issue: On first retrieval of the platform, it was noted that the bend restrictors were separated just behind the transition piece (see Figure 32).

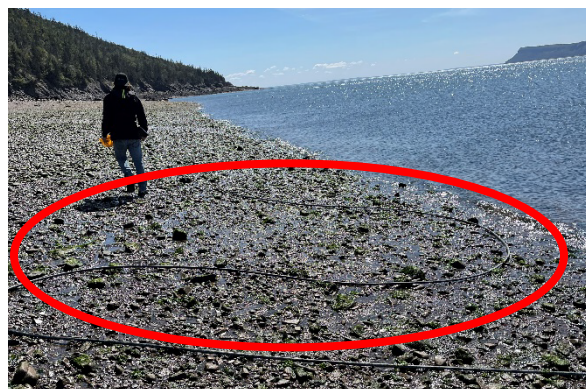
Figure 36: Excess cable on beach after cable lay

Issue: Excess cable from the cable lay operations was simply laid out on the seabed near shore. This caused the cable to move a lot within the first 150 meters of water. The crew was sent out in a small RHIB to try and spread the cable out over a larger area to help prevent the movement of the cable. That was not totally successful as some of the cable kept looping back onshore. A crew was then dispatched to retrieve all the cable possible near the shore at low tide and spill it up the beach. The cable was then coiled up near the beach termination and no further issues with cable movement have been detected.

Solution: Future installations of small cable of this type should be done with the expectation of pulling all remaining excess cable up the beach and secured to the termination area.

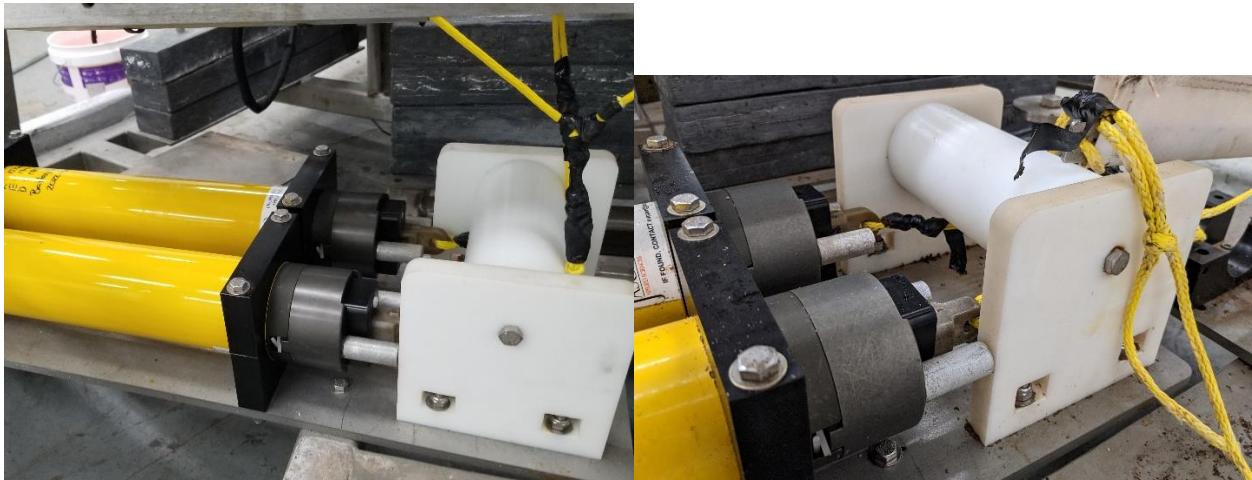
Figure 1. Release mechanism as rigged prior to deployment and post recovery.

It was relayed from the field team to the engineers that the recovery floats were at surface during slack tide before the releases were triggered. This would indicate a failure of some part of the mechanism; either a false release, or a mechanical failure of the parts holding the canvas cover. It is not known how long before the recovery operation this failure happened.

After investigation, the releases did not misfire, and no parts were broken on the release itself. There was some apparent wear on the canvas cover itself. The releases remained in position. There was some biofouling and rust, but no mechanical damage.

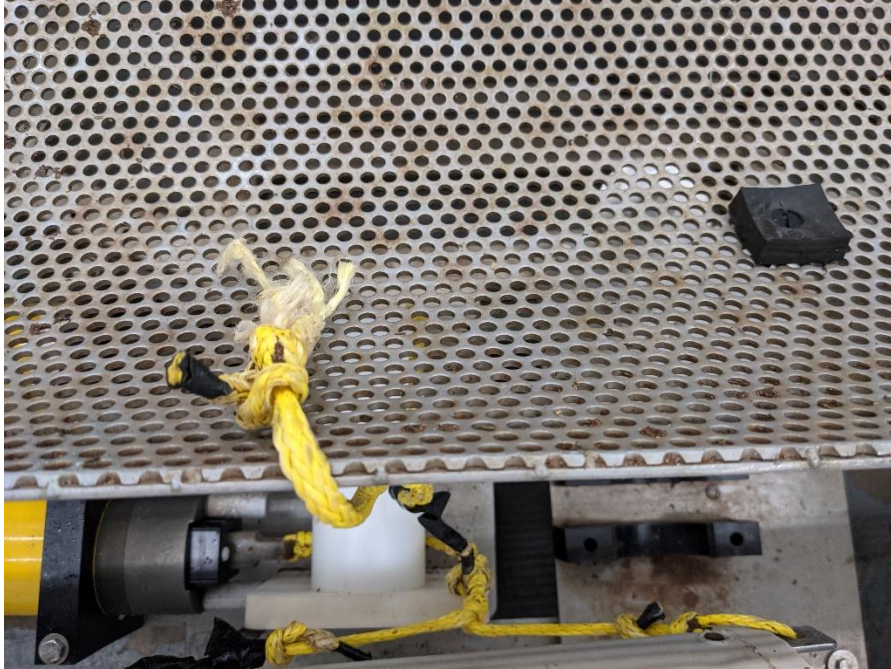
The rope holding the canvas spool cover appears to have chafed to the point of failure where it meets the grommet on one side of the spool cover releasing the recovery floats. The opposite side of the spool cover was intact. Some of the stitching in the spool cover had come undone, but not enough to pose any threat of failure. Some of this damage may have occurred after the rope failure. Doubling up the stitching on the cover may help.

Figure 2. The chafed knot on one side of the spool cover.

A shackle, or other lifting device should be placed on the grommet to reduce chafing and reduce the risk of failure in the future. A more wear-resistant rope can also be used. Jasco commonly uses Polyspec (polyester-jacketed dyneema), although the extra lead time to procure this rope will have to be considered.

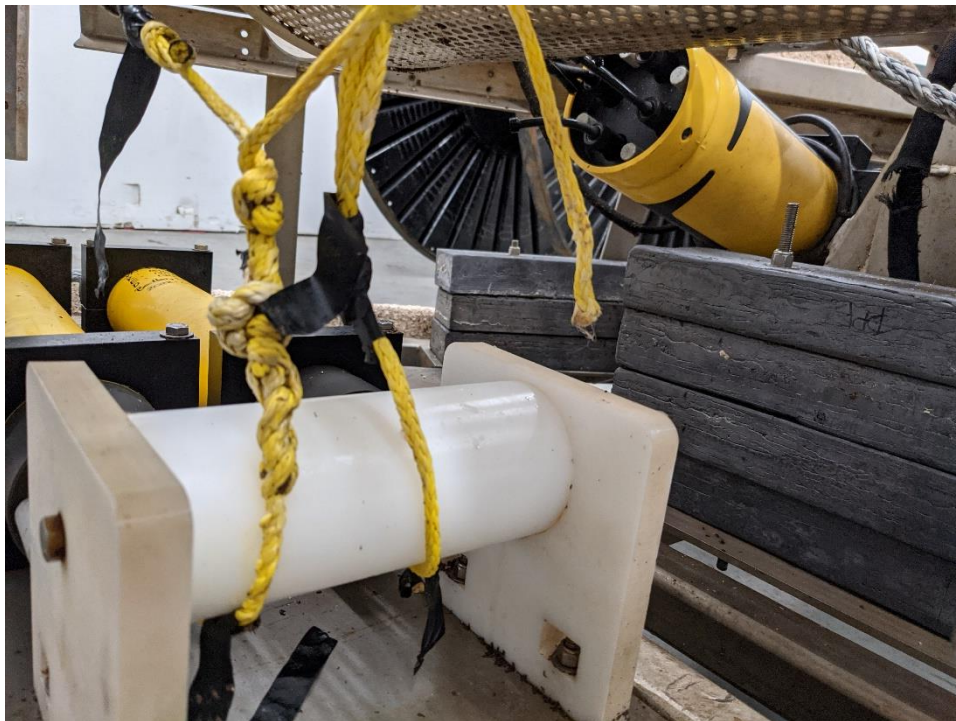
All the knots in the system had been taped over, but after recovery it seems that much of the tape has worn free. Spliced connections would work better but would need to be done with high accuracy with regard to the lengths.

Figure 3. Intact side of cover now missing tape.
