Cabling and Platform Solution
Project 200-215
Final Report
Reporting Period 15 Feb 2022 – 31 Mar 2022

Halagonia Tidal Energy Limited

Project Lead: Sarah Thomas
Project Start Date: 11 Feb 2020

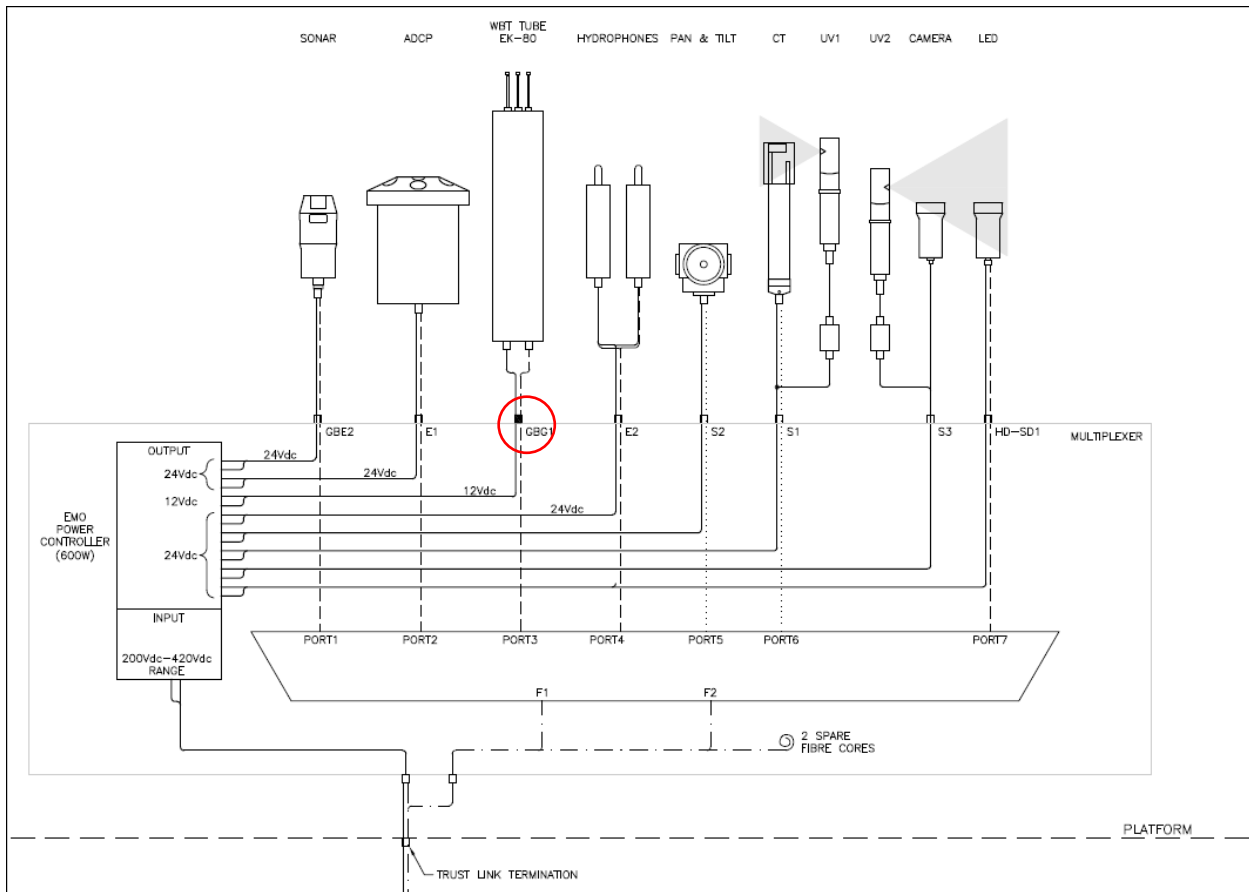
Figure 1: Platform Section

The Echosounder has a designated pin connection as it requires a different voltage than the other equipment. This has been distinguished by a different colour pin in the physical MUX and captured in the drawing and in the pin out table (red circle in Figure 1 above).

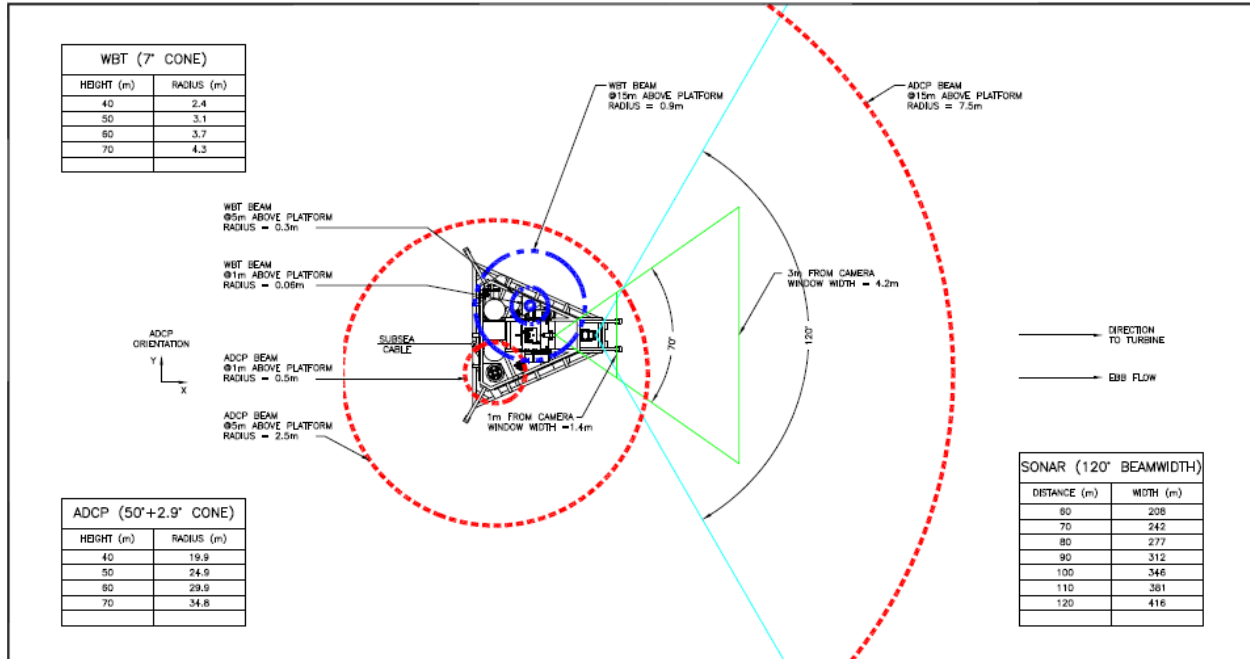
Figure 6: Plan View, Sensor Beam Width Profiles

However, to ensure the ADCP data can be used in any flow analyses, it must have a defined orientation and coordinate system. For this system, the ADCP coordinate system was defined such that the x axis is along the long axis of the platform, parallel to the multiplexor. The WBT transducer is oriented along this axis as well, with the directional arrow facing the back of the platform, away from the Gemini.

The WBT transducer was only positioned in that direction because of the existing bolt holes. Future positioning should be adjusted to match the sonar and ADCP orientation.

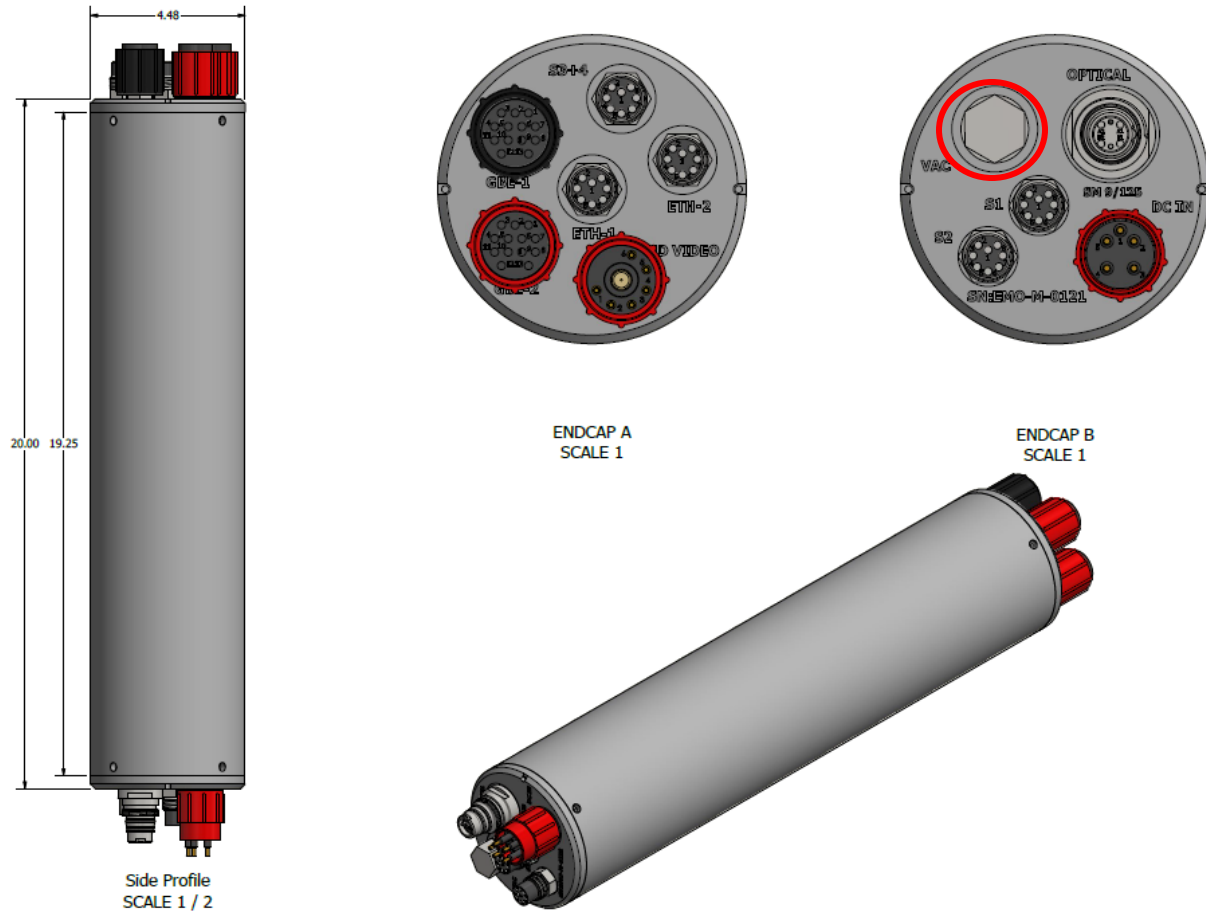
Figure 14: Multiplexor

The VAC plug (circled in Figure 14 above) is the component that showed evidence of corrosion upon recovery in September 2021. This plug is galvanically isolated from the frame through the acetal mounting bracket, so it was not protected by the sacrificial anodes installed on the frame. MacArtney Canada completed a metallurgical analysis and confirmed the component was 316 stainless steel. However, after reviewing documentation from their supplier, it was confirmed that the plug was not passivated and therefore was not protected in the saltwater environment. The component was replaced with a titanium piece in the refurbished MUX.

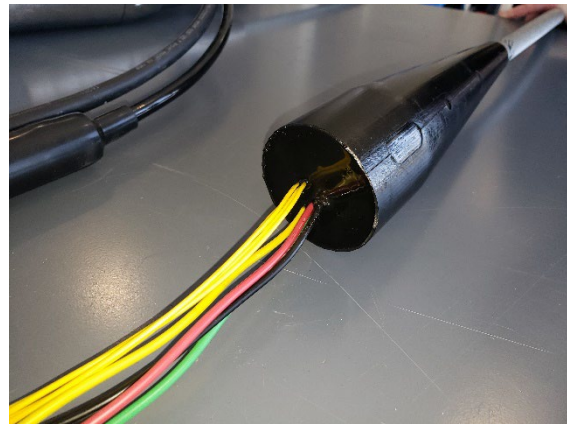
Figure 23: Dry End Overmold

Issue: The termination mould installed on the dry end of the subsea cable was nonstandard and could not be glanded to the Beach Junction Box properly. The conductor and fibres could be easily broken at the edge of the epoxy mould.

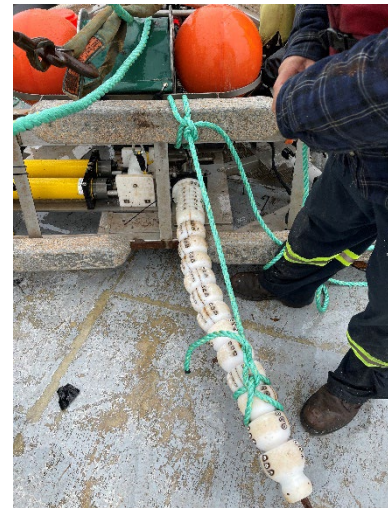
Figure 34: back line attached to Bend Restrictors

In addition, there was also a hold back line attached to the bend restrictors in the event the damage was caused during the platform set down on initial deployment (see Figure 34).
